POST LAUNCH REPORT

MERCURY-ATLAS NO.1

Project MERCURY

August 2, 1960

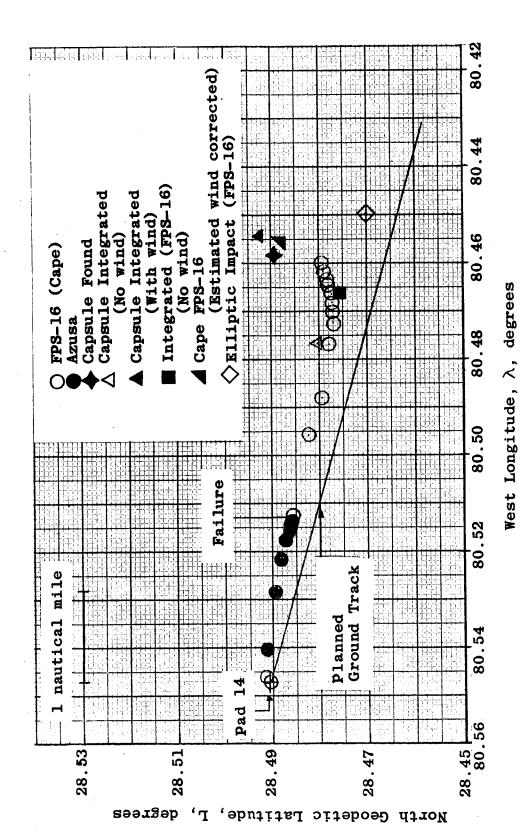
Flight Track, Impact Predictions, and Capsule Wreckage MA-1 Mission Recovery Point. Figure 7.2.1-1

The ground track is shown in figure 7.2.1-1. Because of high winds (see figure 7.1.2-1), the track deviates considerably from the nominal.

A plot of altitude versus range is shown in figure 7.2.1-2. Time histories of trajectory quantities are shown in figures 7.2.1-3 to 7.2.1-5. Figure 7.2.1-1 shows the point where the capsule wreckage was located and recovered after the flight. Also shown are the impact point obtained from the Cape FPS-16 radar tracking, the impact point calculated from the conditions at the termination of powered flight based on G. E. data, and the calculated vacuum and integrated impact prediction computer The calculated and FPS-16 points were corrected impact point. The effects of the high winds at the lower for wind effects. altitudes can be noticed in the initial phase of the ascent and in the descent at altitudes below 30,000 feet. impact points supplied to the recovery forces immediately after flight were the FPS-16 elliptic and integrated values obtained from the impact prediction computer. More refined values were supplied on the day following the flight.

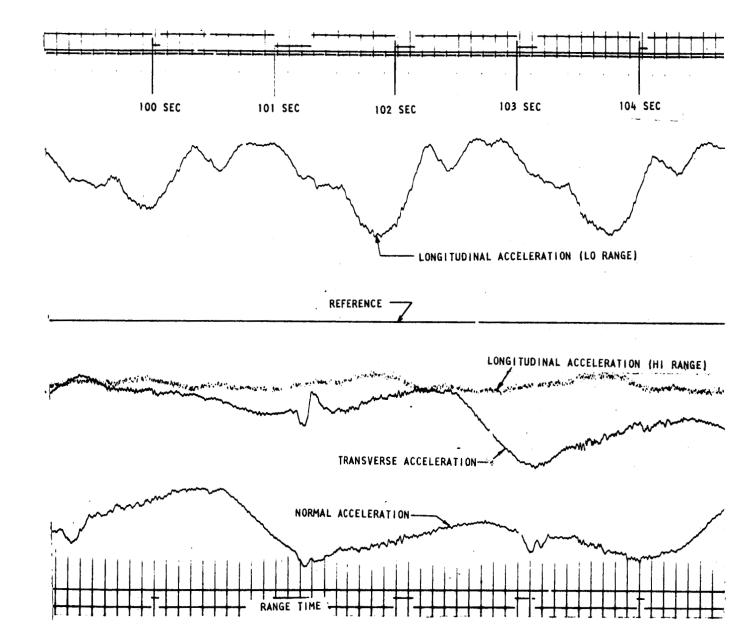
FIGURE 7.3.1-3 CAPSULE ACCELERATIONS NEAR T=100 SEC

Shown in figures 7.3.1-3 and 7.3.1-4 are the capsule acceleration and rate measurements near T+101 seconds. From radar tracking, the capsule at this time was at an altitude of approximately 40,000 feet and was descending. The rates and accelerations shown in this figure are typical for a tumbling maneuver.

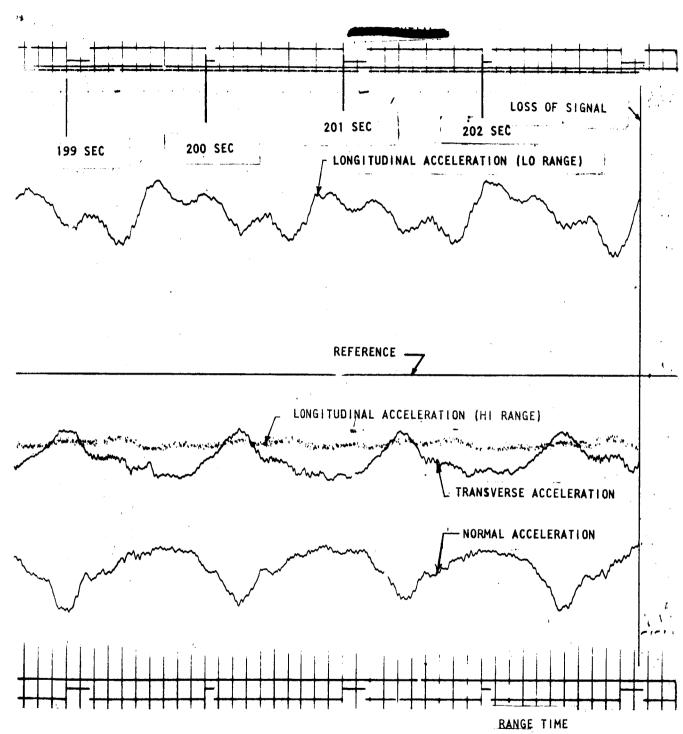
FIGURE 7.3.1-5 CAPSULE ACCELERATIONS PRIOR TO LOSS OF SIGNAL

The capsule accelerations and rates just before impact are shown in figures 7.3.1-5 and 7.3.1-6. The characteristics of the curves are again typical of a rapidly rolling and tumbling body.

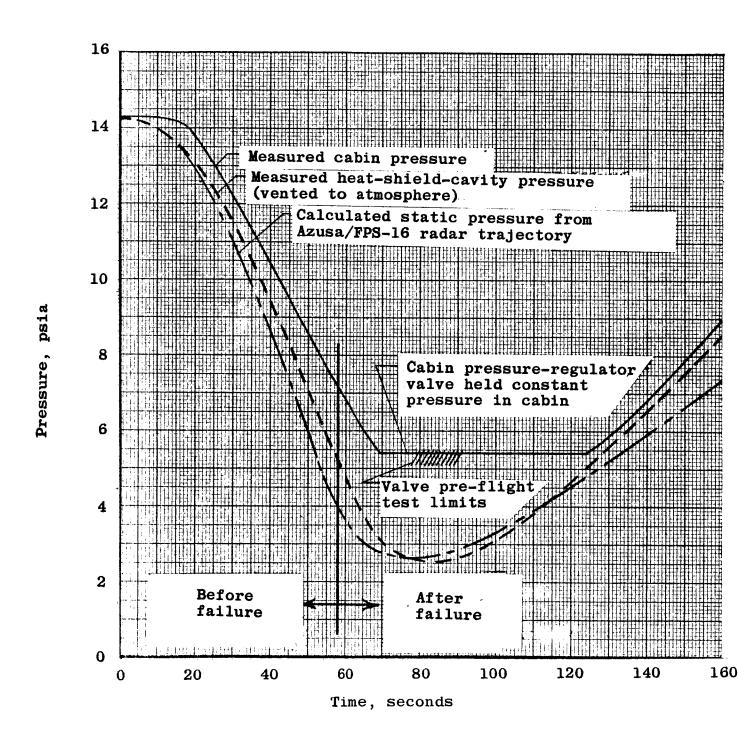
Figure 7.3.3-1 - MA-1 capsule pressure measurements

The cabin pressure regulating valve located on the small pressure bulkhead appeared to function properly. The pressure decreased with altitude until the regulating pressure of approximately 5.4 psia was reached. At this point the cabin pressure held constant for about 50 seconds indicating that cabin leaks, if any, were negligible. The valve opened again during descent and equalized the pressure satisfactorily.

It should be noted that the valve continued to operate satisfactorily after the booster failure and that the cabin pressure remained constant during the time the valve was closed. It thus appears that the capsule pressure vessel remained structurally sound and sealed during and after the booster malfunction. There was no pressurization system on board the capsule.

From the pressure and temperature measurements discussed in this section, there is strong evidence that the capsule remained intact and structurally sound, during and after the booster malfunction, down to capsule impact.
